DEVELOPMENT OF DESIGN, TEST AND ACCEPTANCE CRITERIA FOR ARMY HELICOPTER TRANSPARENT ENCLOSURES

PPG Industries, Incorporated

September 1973

USAAMRDL TECHNICAL REPORT 73-65

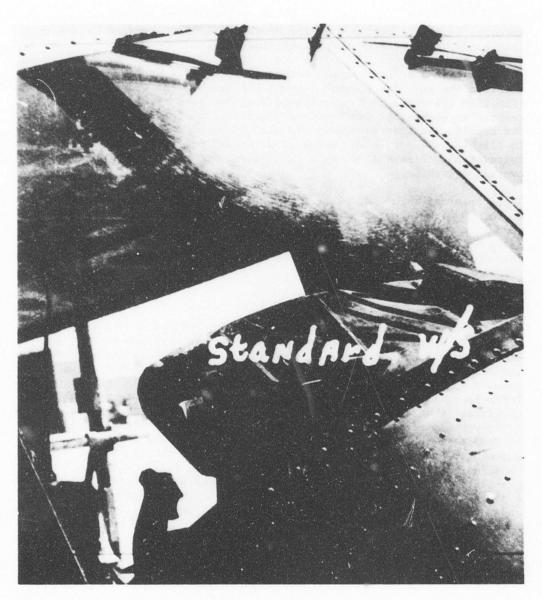
Scratches on the surface represent the most common and widespread defect found. By far the most common cause was from windshield-wipers used on plastic-faced parts. Figure 14 shows wiper scratches on the UH-1. Similar damage was much less common on glass surfaces and were generally

Figure 14. Wiper Scratches on Plastic Windshield, UH-1.

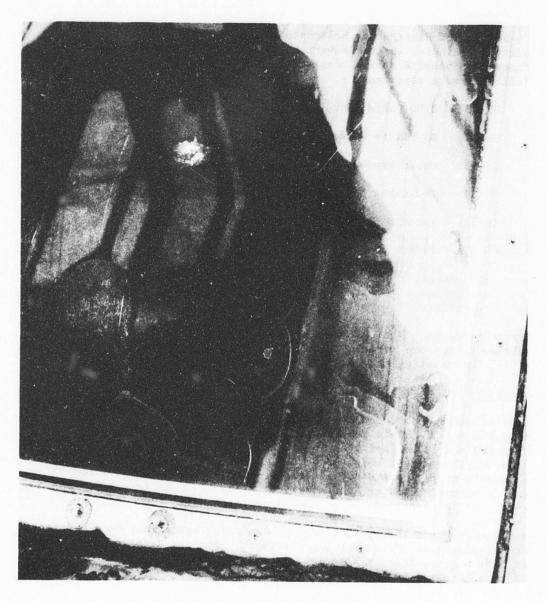
Differences in the coefficient of thermal expansion of materials in a laminate affect delamination. The coefficient of thermal expansion of the normal interlayer material (PVB) is approximately ten times that of glass. As a laminate of glass/PVB/glass experiences gross temperature changes, extremely high shear forces parallel to the surface exist at the glass-PVB interface that contribute to adhesion failure. This is also true for glass/PVB/acrylic composites. However, additional bending stresses exist because of the unbalanced glass-acrylic configuration.

Figure 23. Severe Delamination of Plastic Windshield, CH-47.

Since the thermal expansion coefficient of acrylic approaches that of the interlayer the combined stresses can lead to early delamination in unbalanced composite structures.

Water vapor entrance through the edge of laminated parts must be prevented by the use of bumper strips and edge sealants. Sealant deterioration and/or improper application especially on replacement installations can permit attack that leads to delamination.
